Debris/Ice/TPS Assessment And Photographic Analysis For Shuttle Mission STS-31R

June 1990

Charles G. Stevenson
NASA/Kennedy Space Center

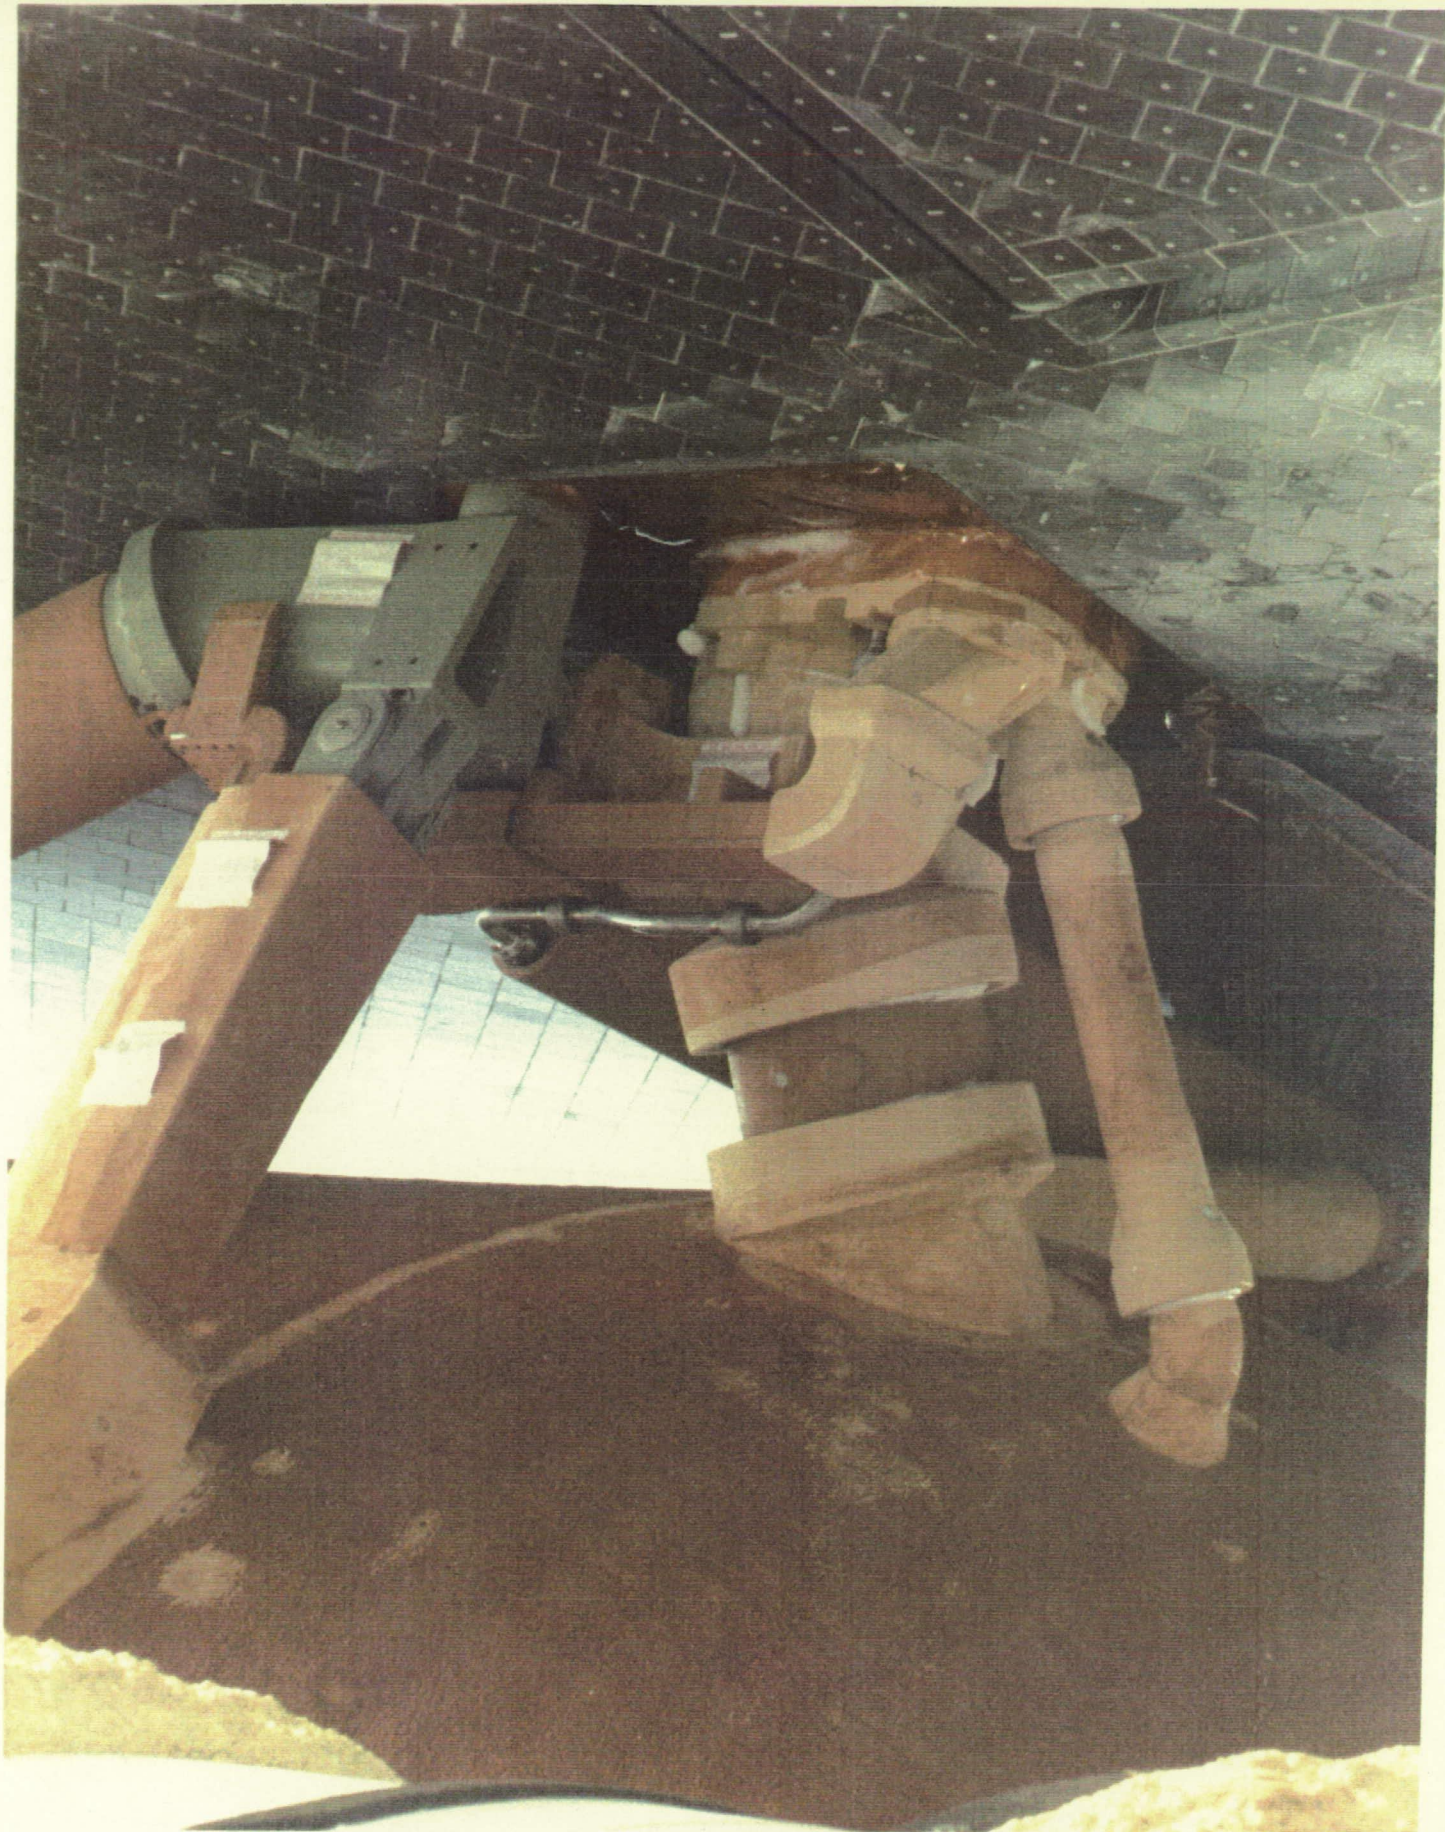
Hard ice is still present on the LH2 umbilical outboard side,
purge vents, feedline and recirc line bellows after ET drain

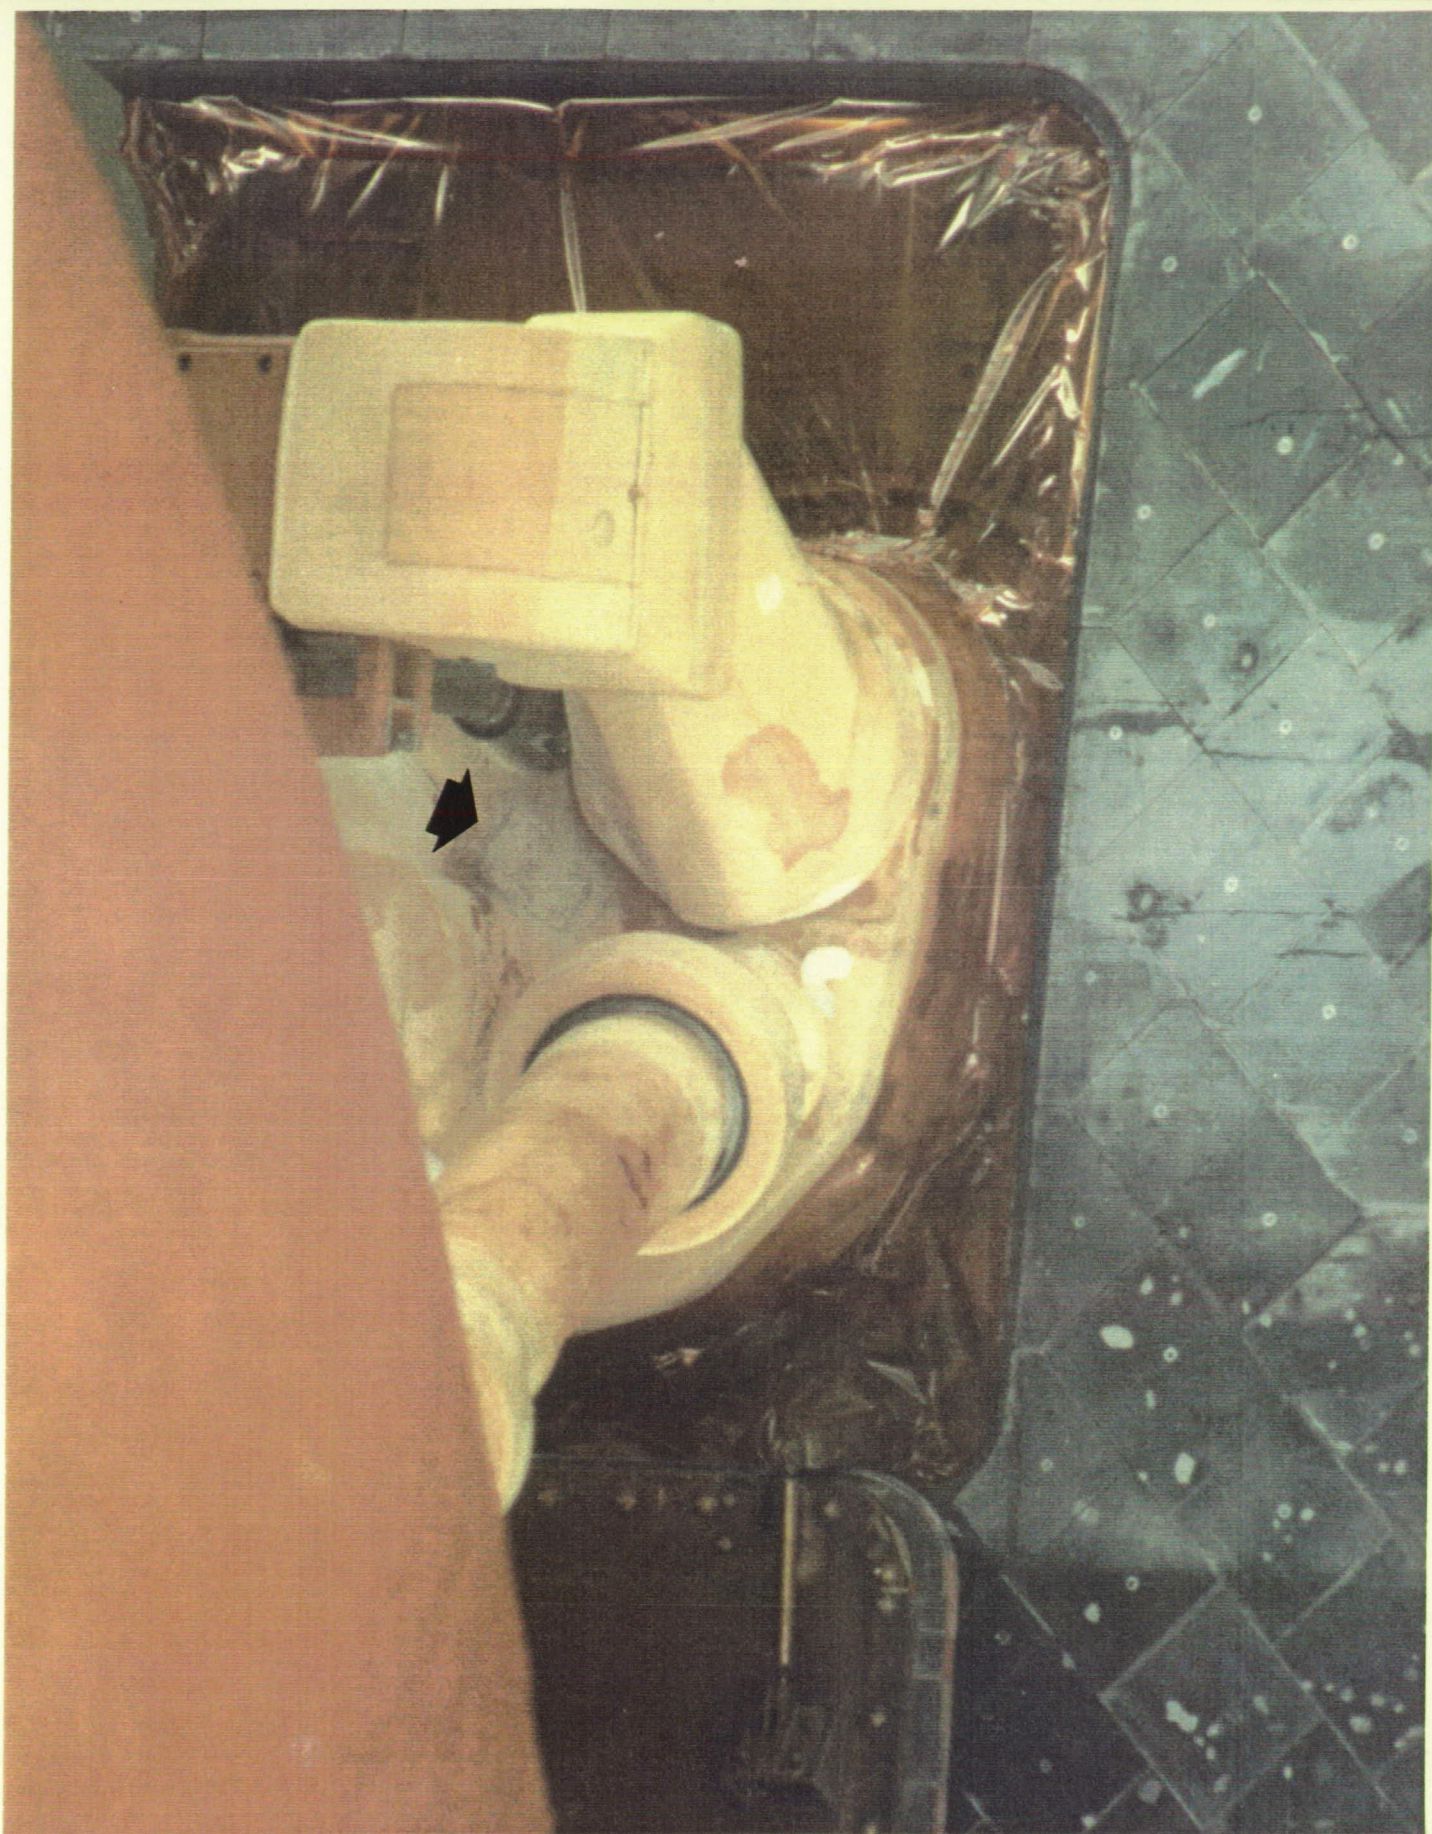
The PDL foam plug in the flapper valve actuator torque tool port closeout shows no anomalies after the first cryo-load

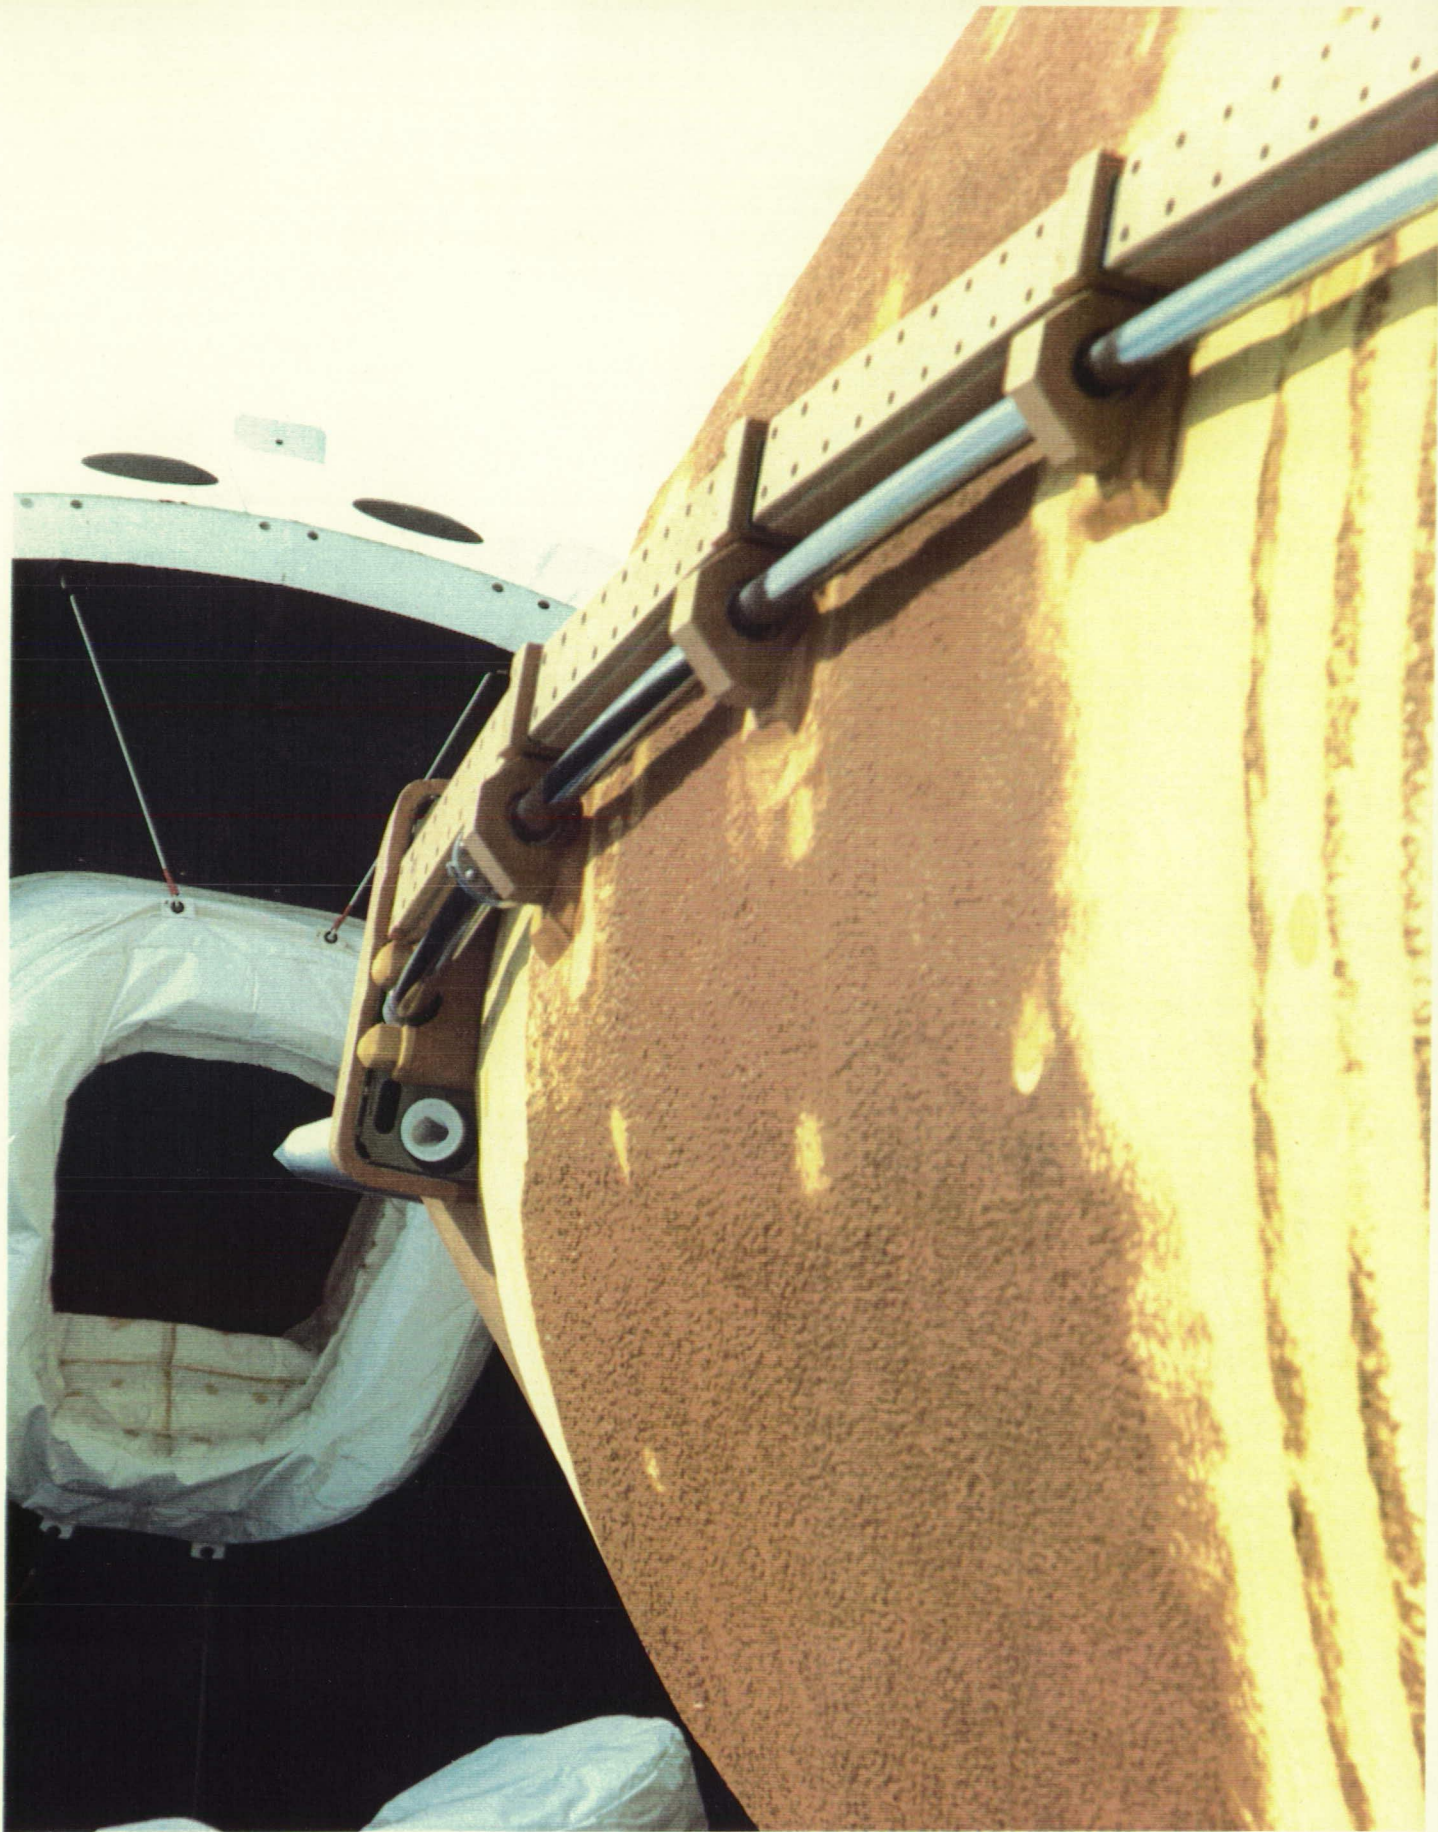
Prelaunch condition of ET tumble valve cover

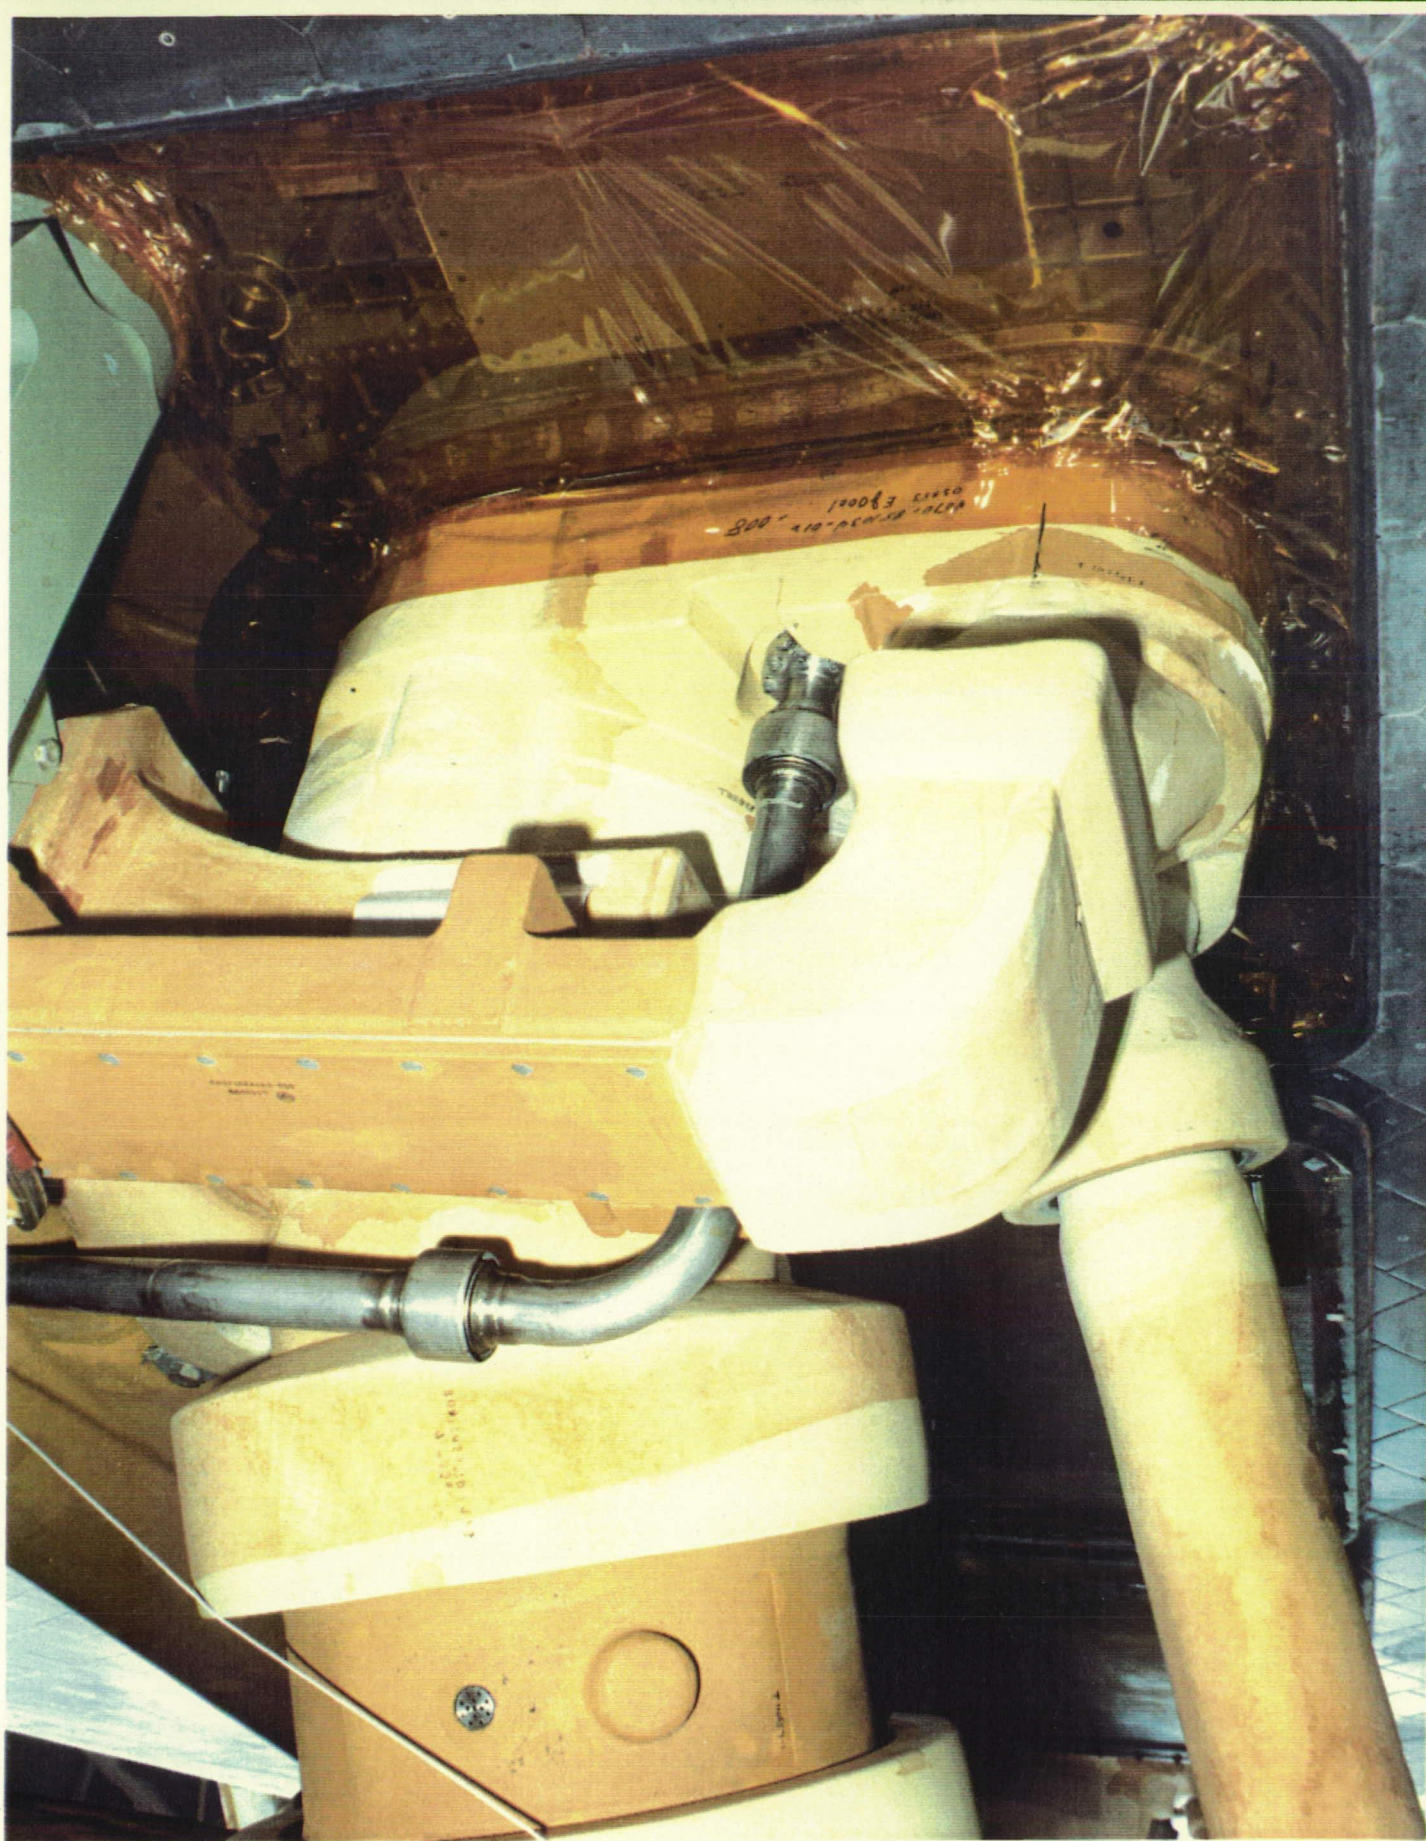
LH2 ET/ORB umbilical prior to second cryo-load. Cord in upper left corner is attached to hydrogen detection system tygon tube

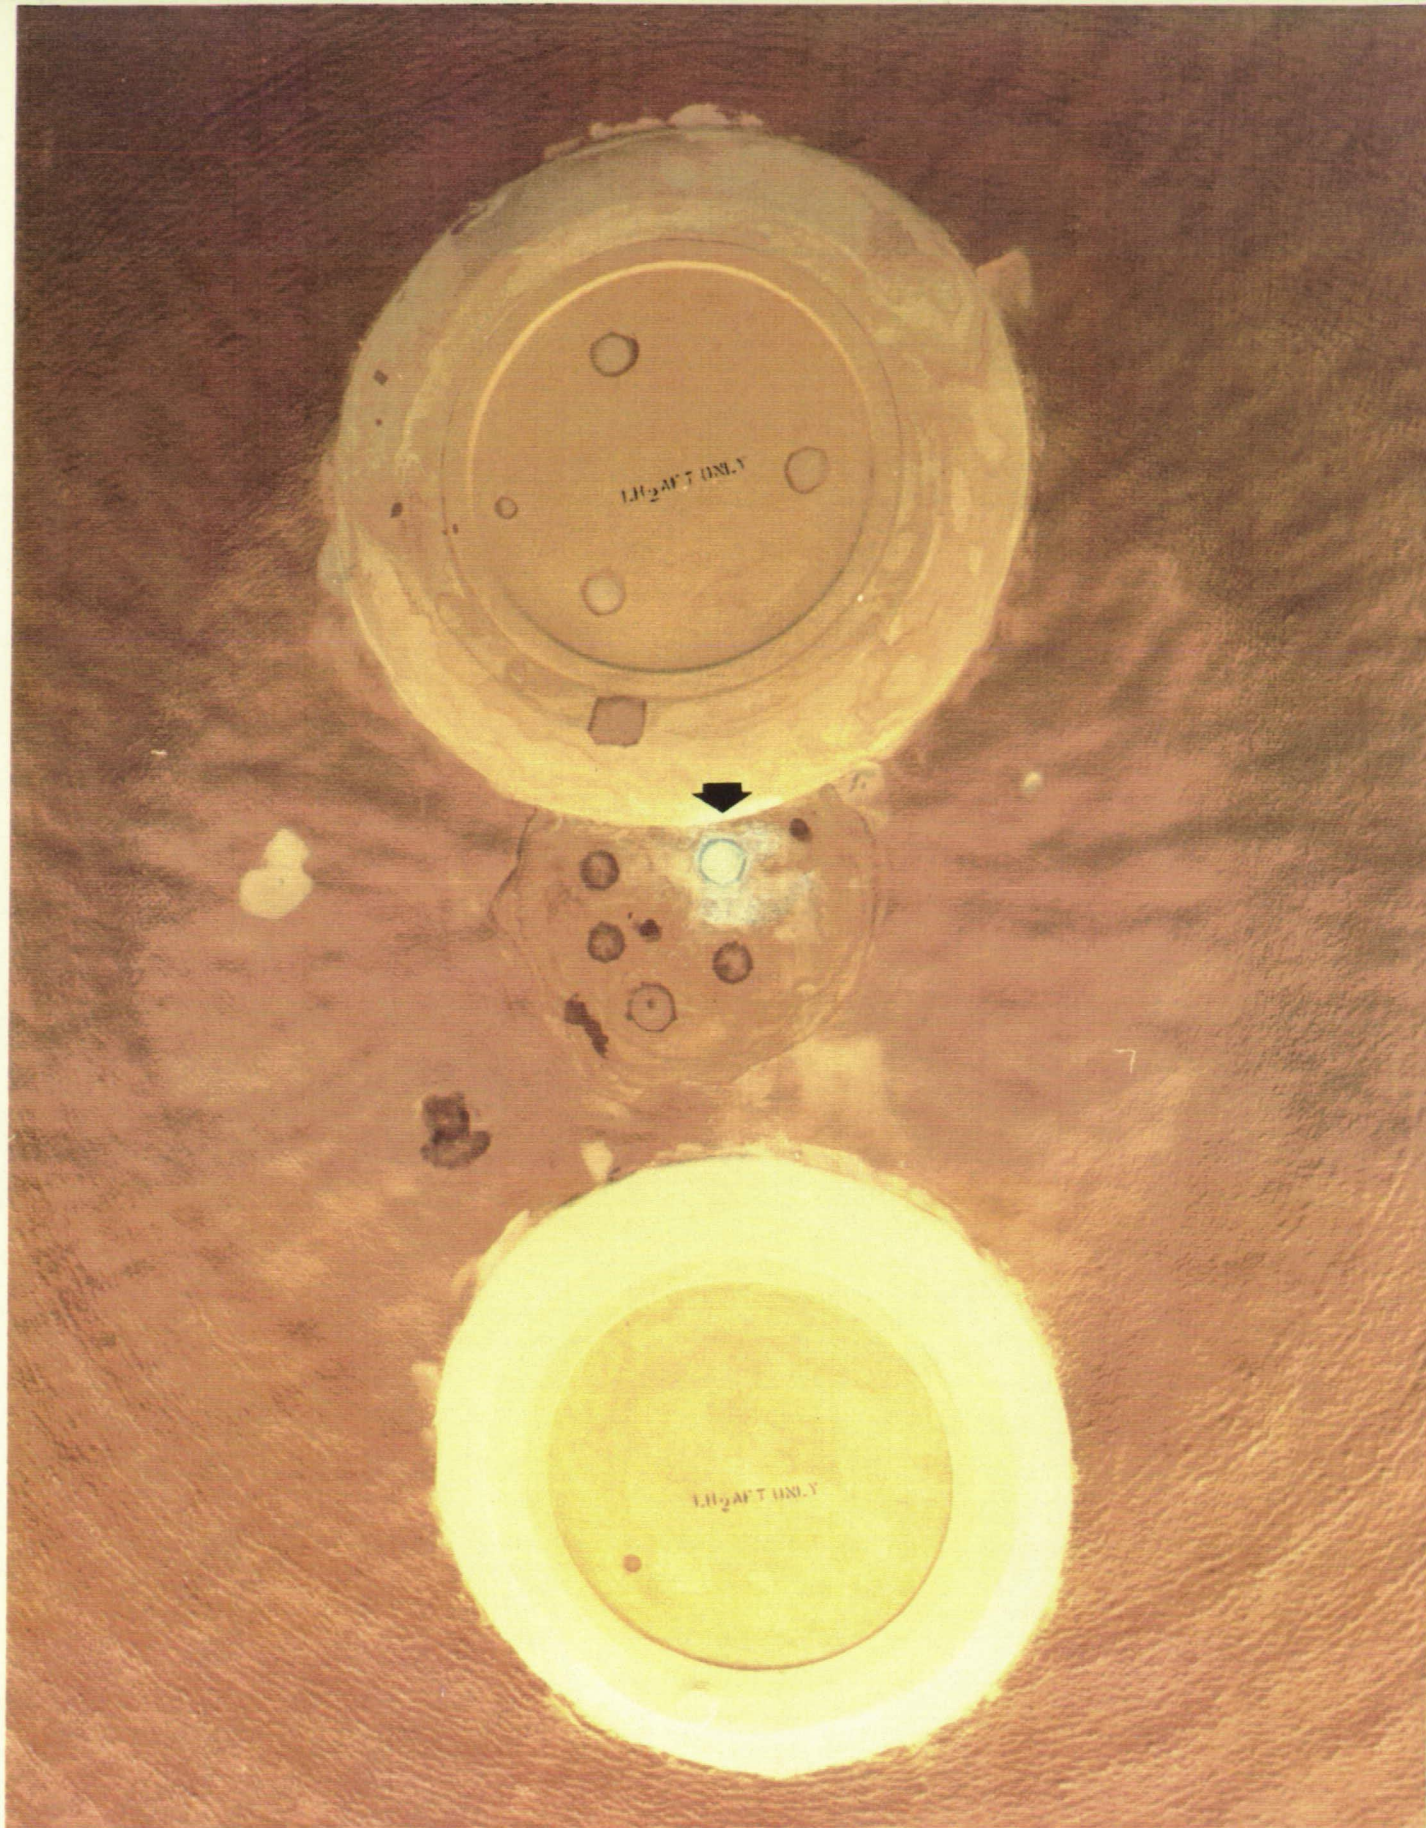
During the reinstallation of the hydrogen detection system tygon tubing for the second launch attempt, a 3-inch diameter foam repair in the LH2 tank aft dome apex was discovered to be missing. This condition was repaired per PR ET-34-TS-0044 prior to launch.

3-inch diameter repair on the ET aft dome apex fell out after drain and was repaired prior to the second cryo-load

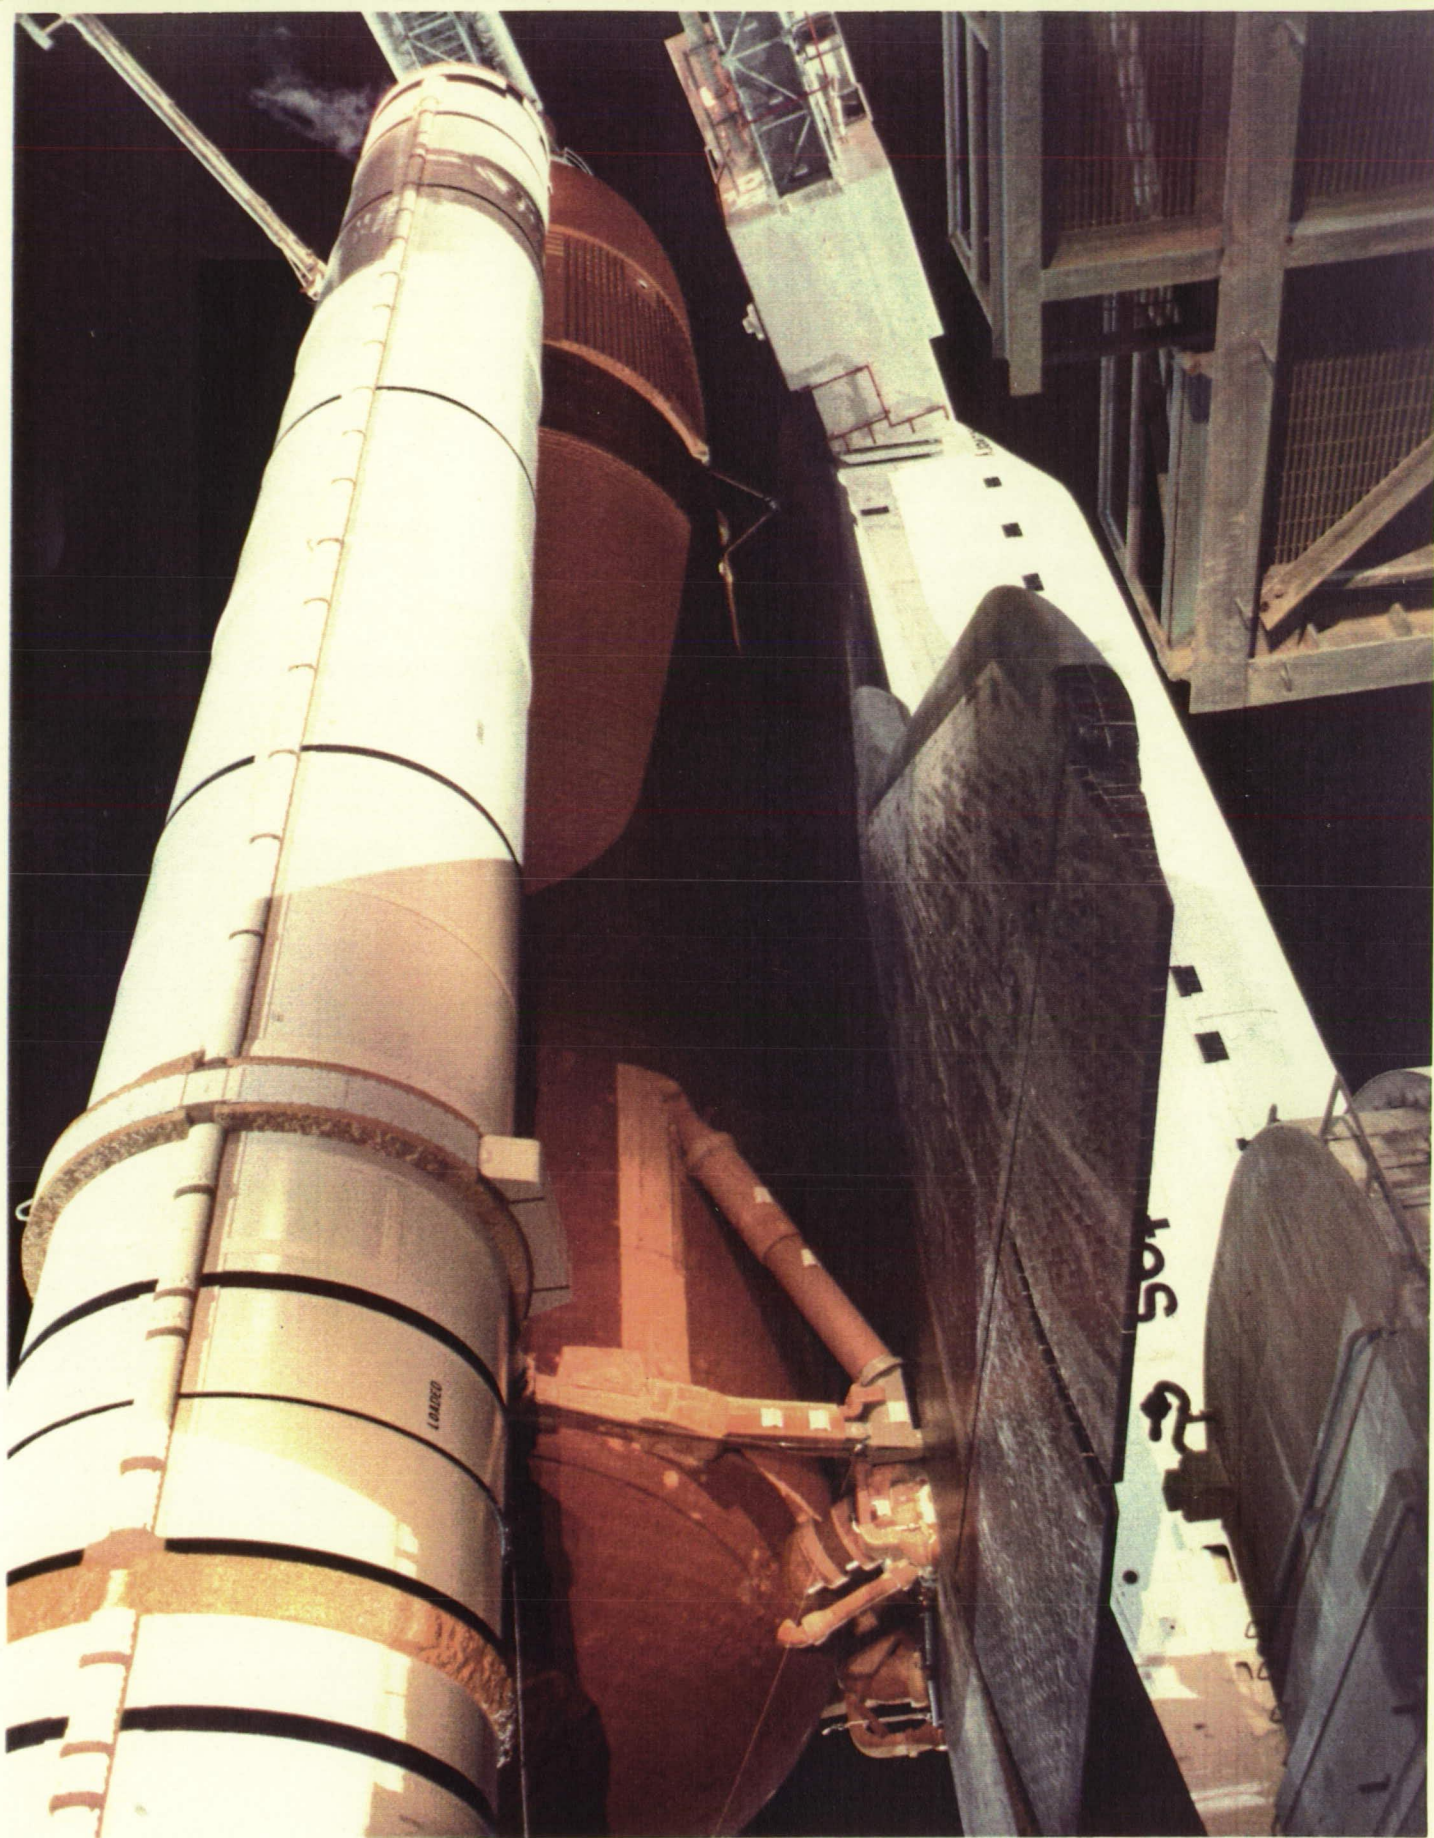
No acreage ice/frost had formed on the -Y+Z side of the tank

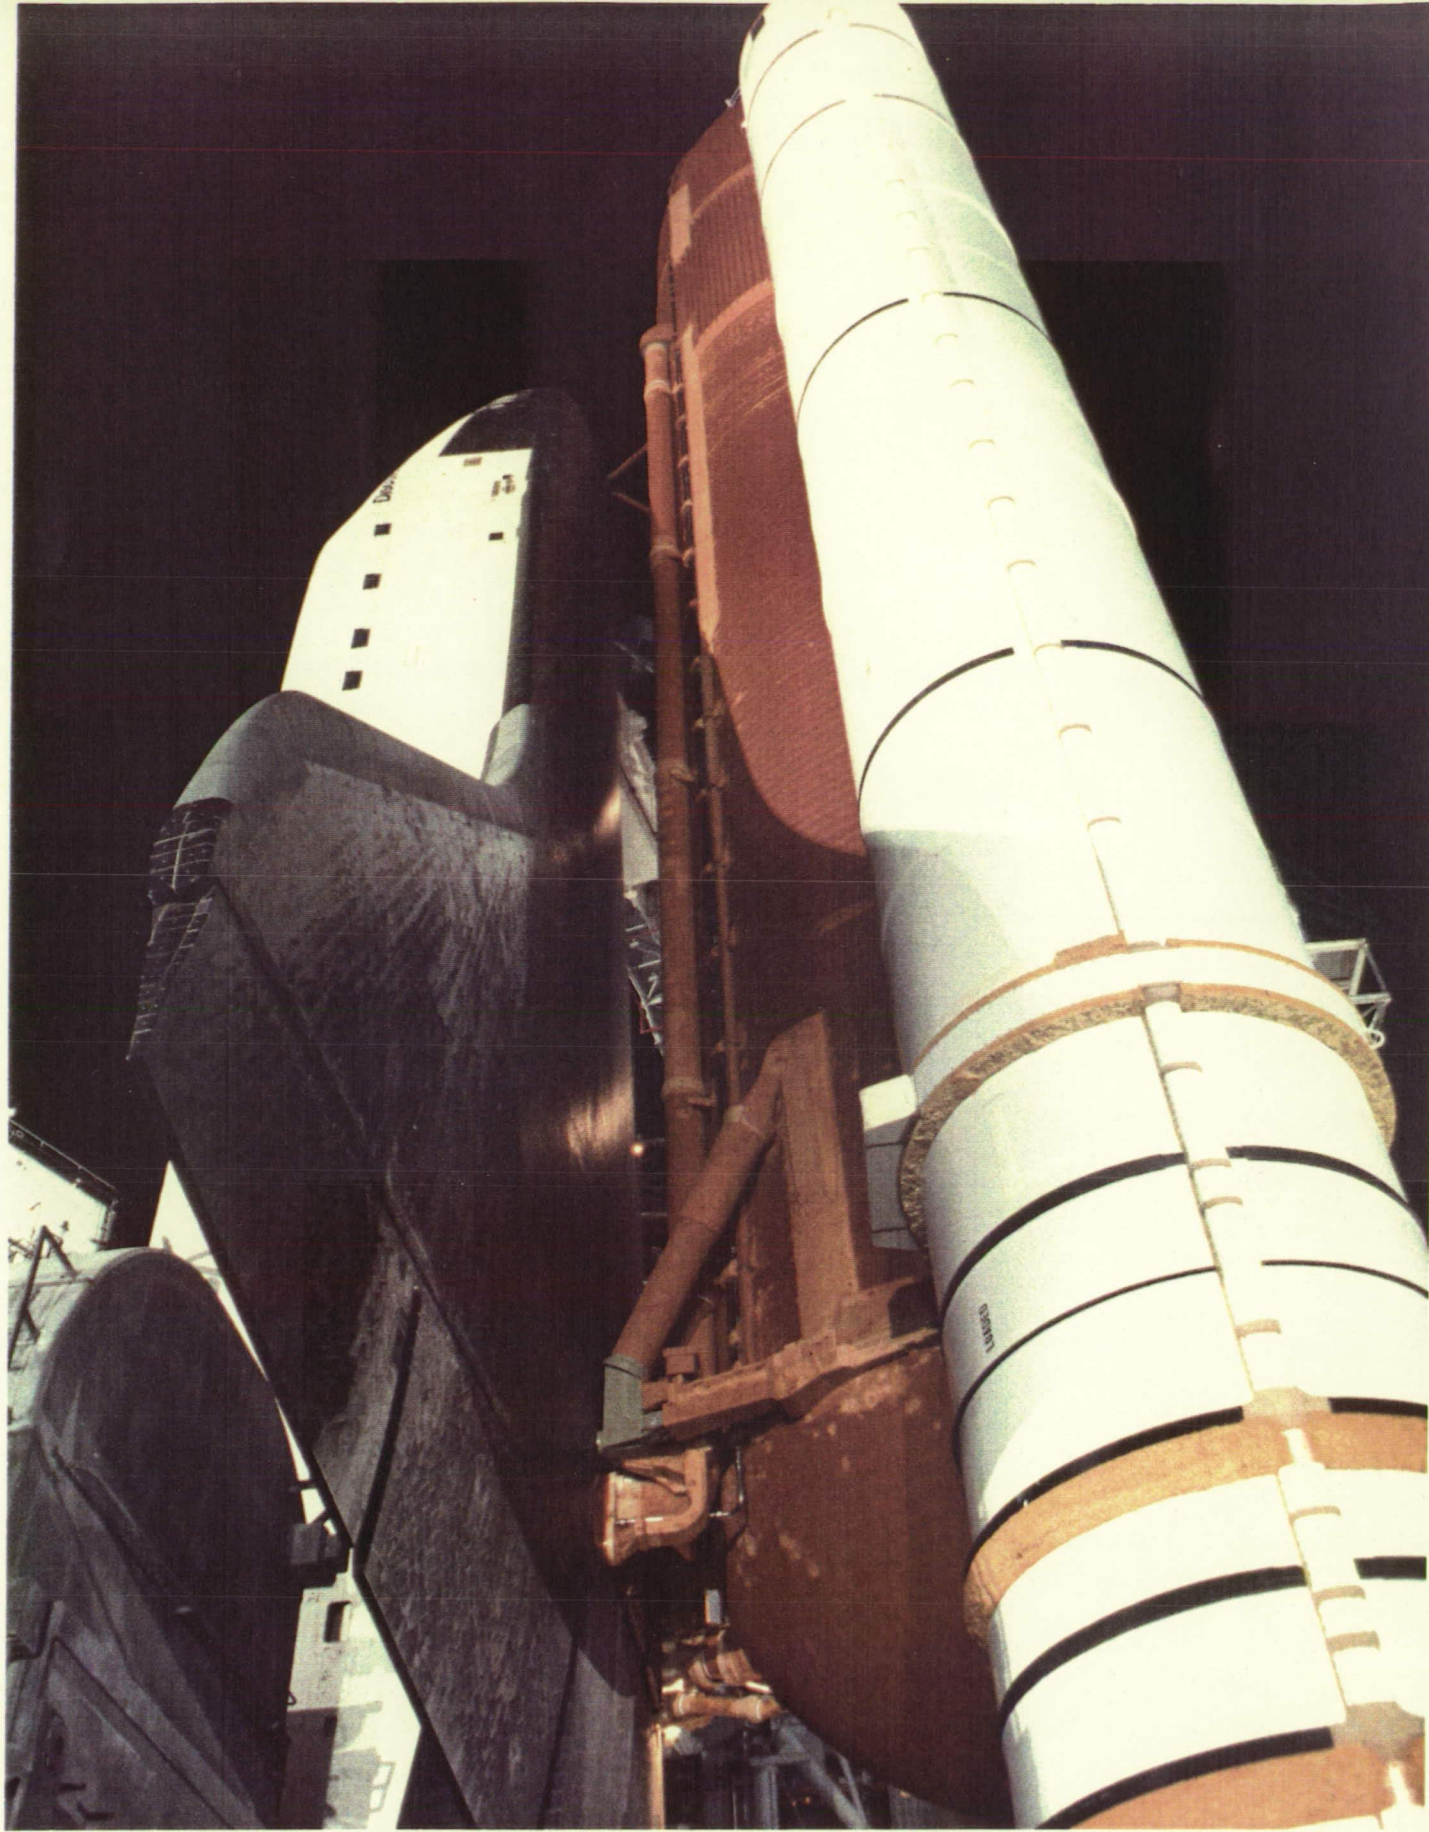
No acreage ice/frost had formed on the +Y+Z side of the tank

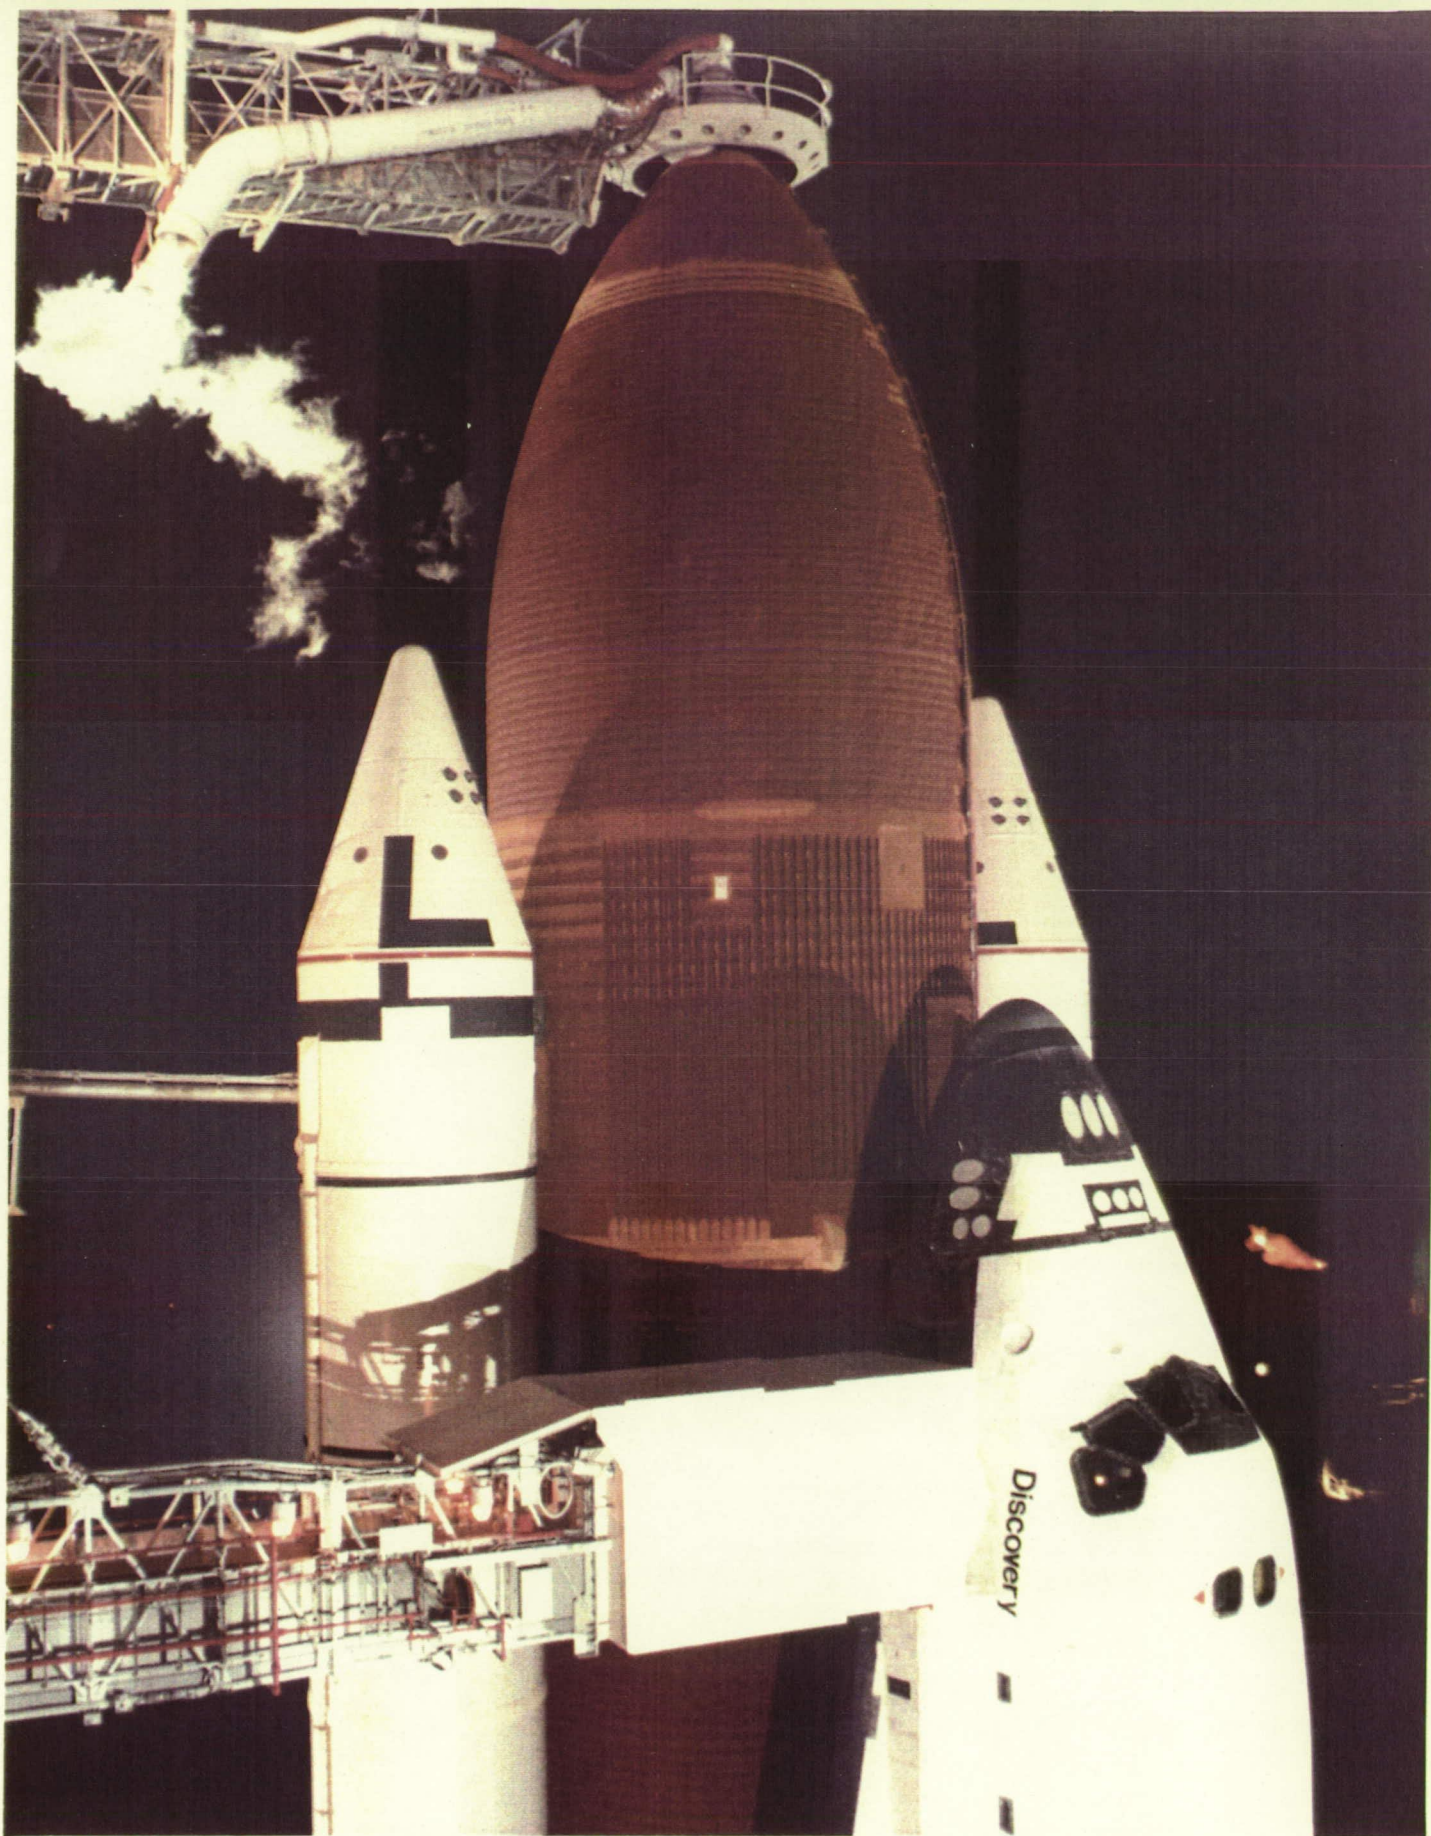
There was no ice/frost accumulation on the LO₂ tank ogive or barrel section. GOX duct vapors were not near the vehicle.
